RR451 WIRING SCHEME FOR 2 WIRE ALTERNATOR (MOST COMMON SCHEME)

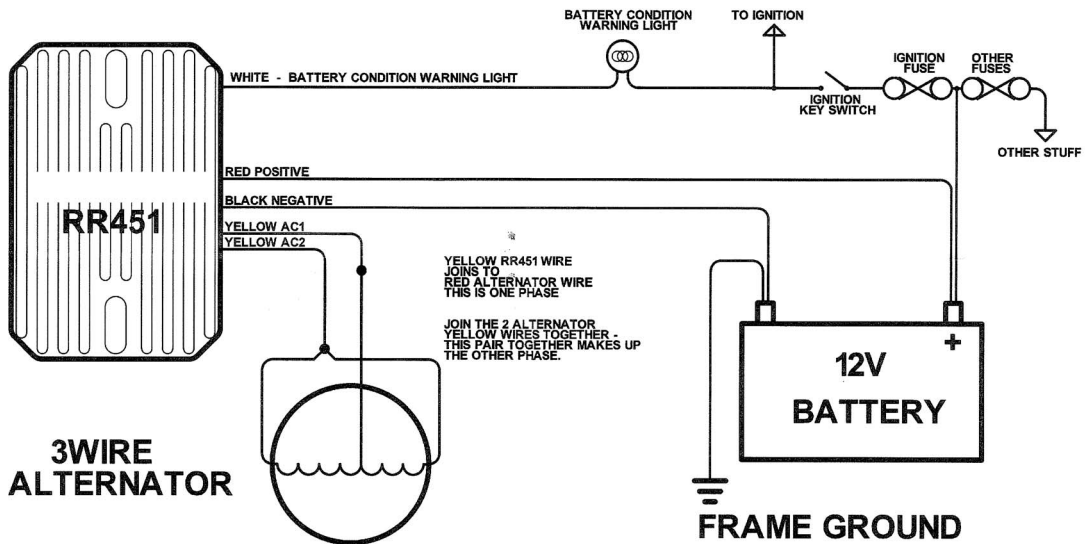
ALTERNATIVE RR451 WIRING SCHEME FOR 3 WIRE ALTERNATOR

Problems with poor charging are usually caused by poor connections, or by not connecting **RED POSITIVE** & **BLACK NEGATIVE** wires **DIRECTLY** to the battery.

Please **SOLDER** all crimp connections after crimping.
